Belzona Repair Worn Caterpillar Bulldozer Arms

Caterpillar Bulldozer bucket arms

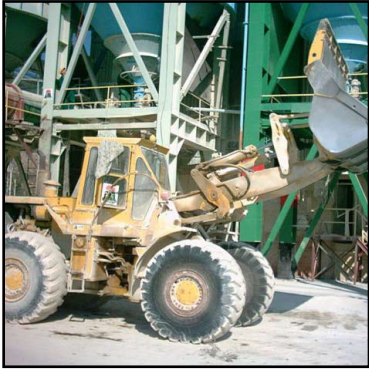
Caterpillar bulldozer

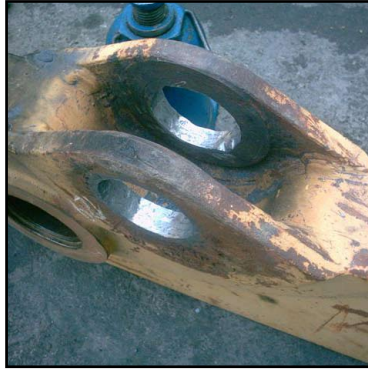
Close up of the damage

The pivot points for the buckets hydraulic rams had become very worn and were no longer serviceable.

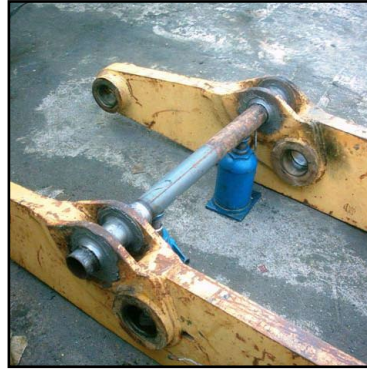
Repair in progress

Application was carried out in accordance with a modified version of Belzona® Know-How System Leaflet MPT-8.

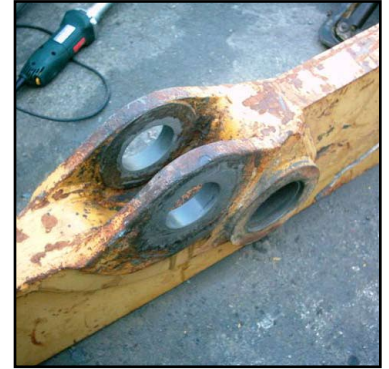
Finished repair

The Belzona repair was chosen because it was easier, cheaper, and faster than conventional methods (welding or replacement) ensuring that the bulldozer was back into service very much quicker and at a fraction of the cost of replacing the arms.
