Belzona Chiller Protection

Five star hotel,
Egypt

Chiller unit from the hotel air conditioning plant

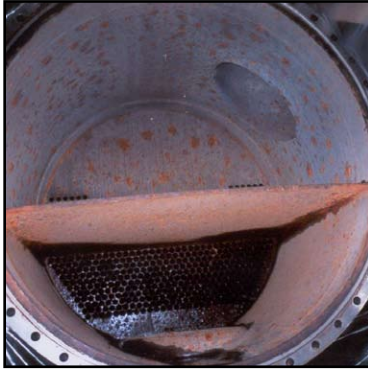
The corroded water box.

Corrosion of the tube sheet and water box.

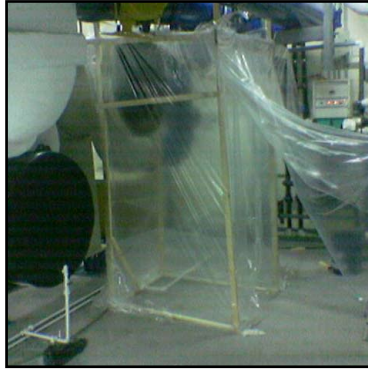
Surface preparation.

Application was carried out in accordance with Belzona Know-How System Leaflet HEX-3.

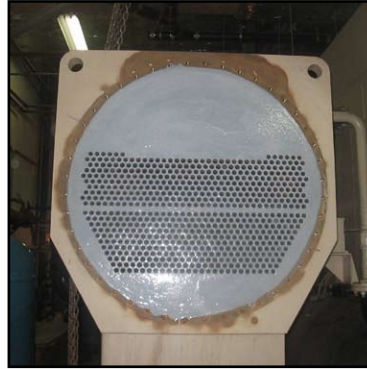
Tube sheet completed.

Belzona® 1341
(Supermetalglide)

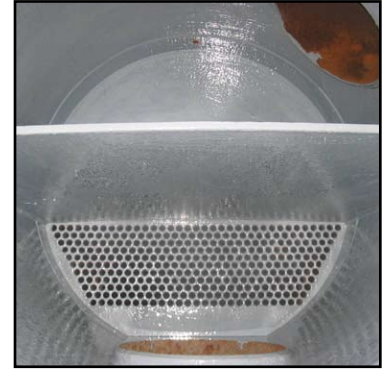
Water box completed.

Long term protection was provided with minimum down time. The preparation and application arrangements did not disrupt the hotels operation as required by the management.
