Belzona Rebuilds Bearing Supports on Huge Excavator

Open Cast Brown Coal Mine
Poland

July 1993

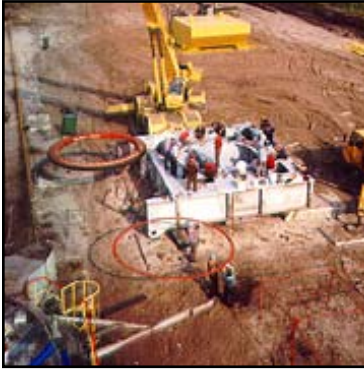
General view of the excavator partially dismantled for maintenance

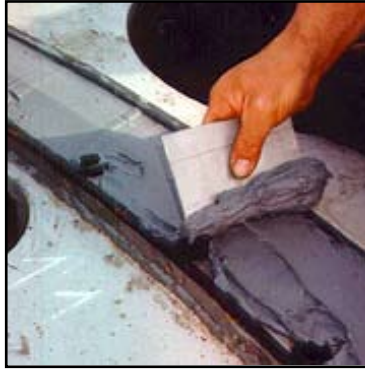
Erosion of support surface for crown bearing

Application of Belzona® 1111

Application was carried out in accordance with Belzona® Know How Leaflet ENC-7
