Belzona Protection to Butane Tank Base

International Petroleum Co.,
Australia

Belzona[®] 3211
(Lagseal)

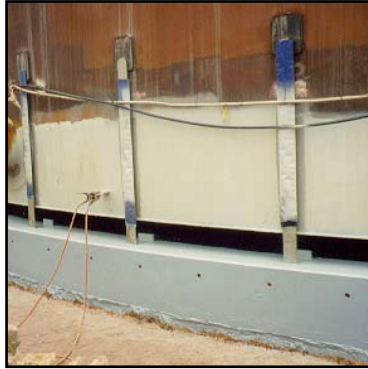
Preparation of tank and base underway. Tank jacked up and ready to install new timber

Corrosion at base of tank. At same time, timber supports were being renewed.

Belzona application creates a flexible, waterproof but microporous seal at junction of tank and base to provide long-term corrosion protection.

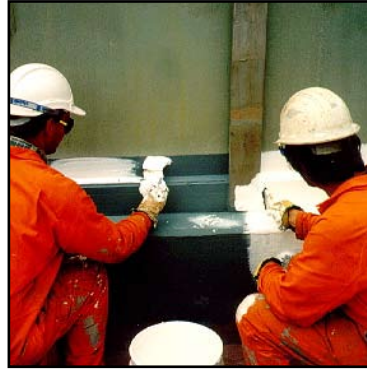
Application underway

Application was carried out in accordance with Belzona Know-How System Leaflet GSS-3.
